RECONNAISSANCE PRESERVATION ASSESSMENT FOR MEMORY HILL CEMETERY, CITY OF MILLEDGEVILLE, GEORGIA

Chicora Research Contribution 445

Prepared By:
Michael Trinkley, Ph.D.

May 31, 2006

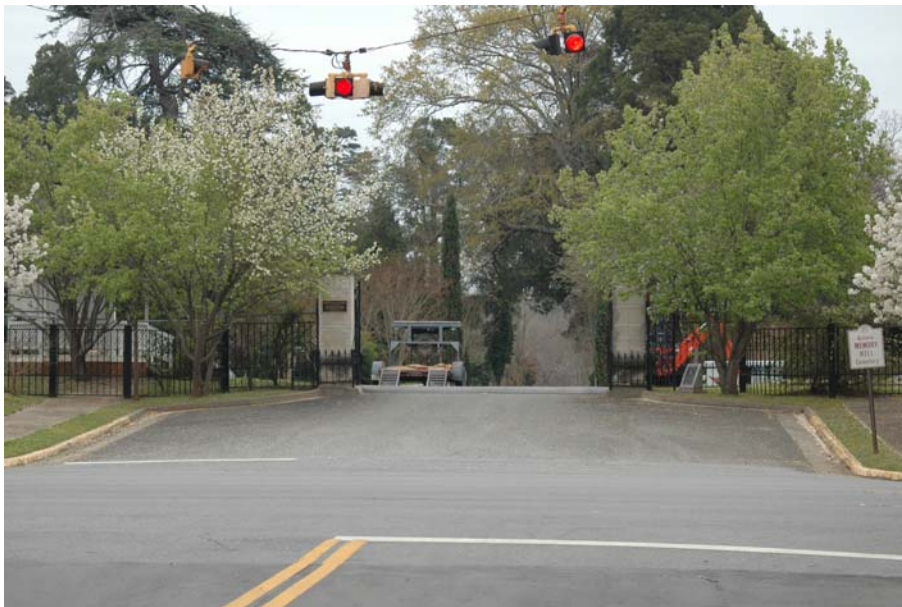
Figure 1. View of entrance to Memory Hill Cemetery looking south from South Liberty Street across West Franklin Street.

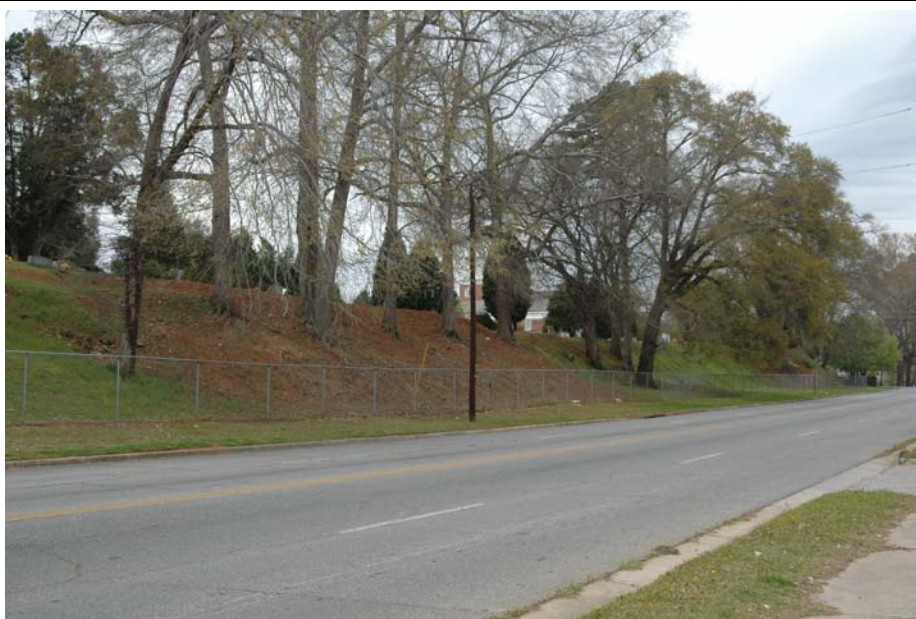
Figure 2. Steep slope from South Wilkinson Street up to the cemetery.

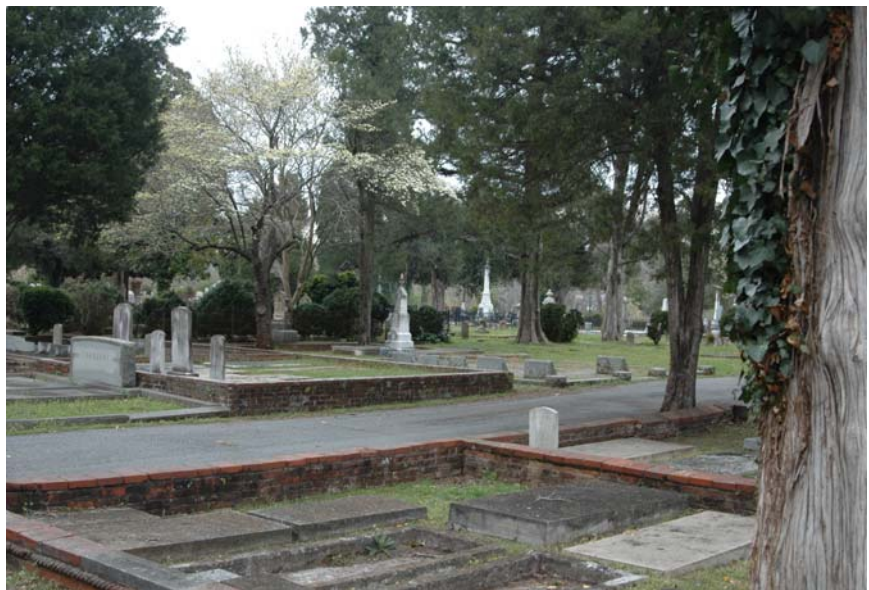
Figure 5. Much of the cemetery is dominated by family plots and three dimensional monuments.

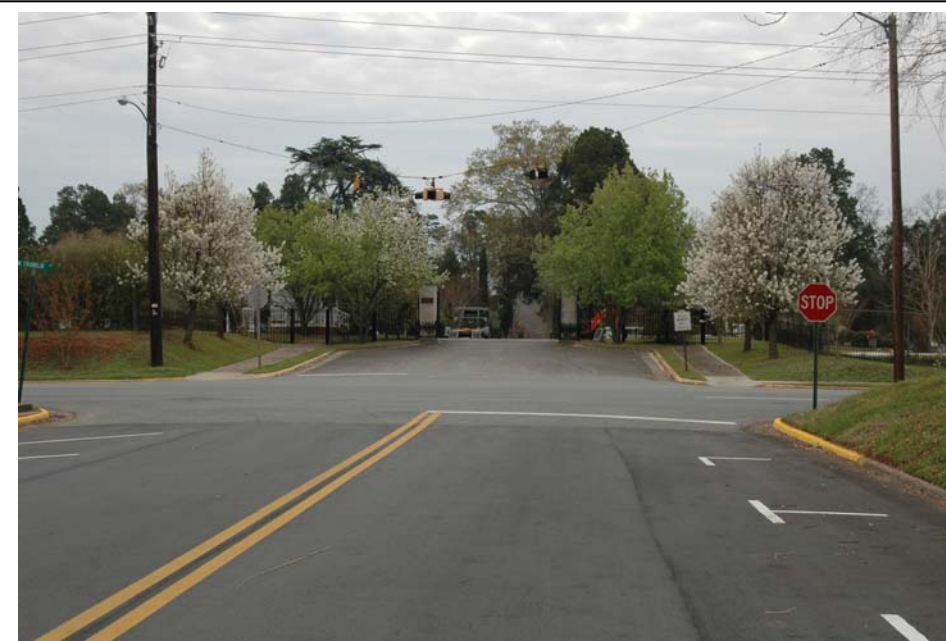
Figure 9. The main entrance lacks interest and fails to present a historic theme or context. The plantings detract from the overall appearance.

The main gate or entrance is the focal point of the cemetery, yet it is rather nondescript and offers no particularly dramatic entrance (Figure 9). The recessed two-lane entrance consists of two sandstone columns. What appears to be original fencing is now entirely decorative, having been replaced with a taller and less ornate iron fence. Much of this fence, as well as the gates and entrance in general, are obscured by plantings which appear

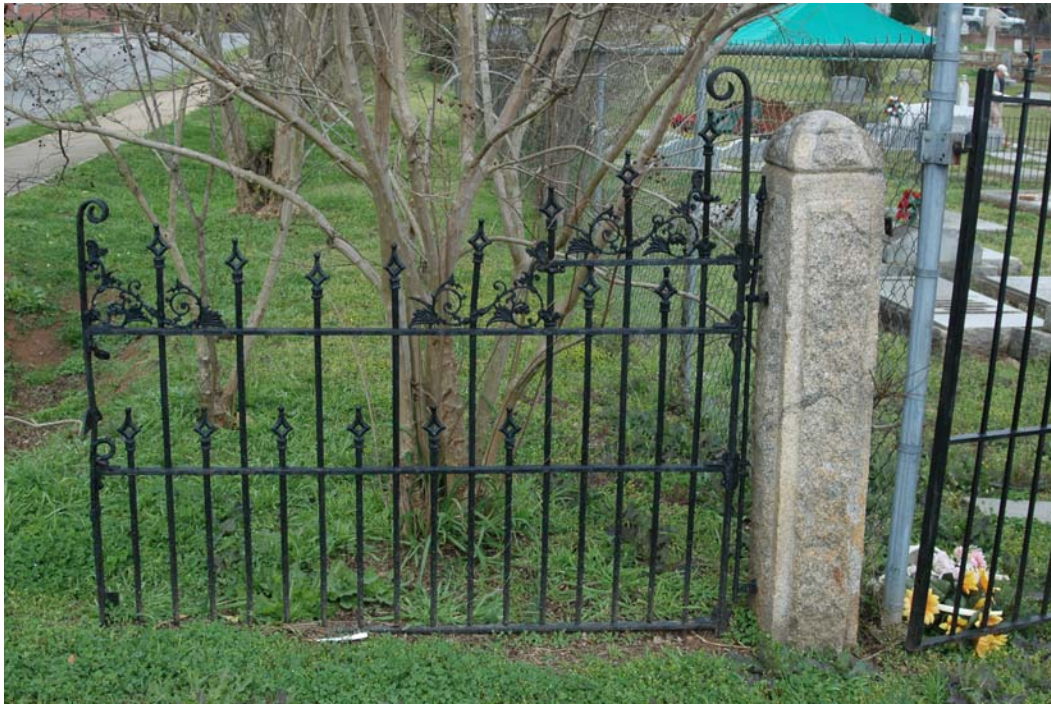
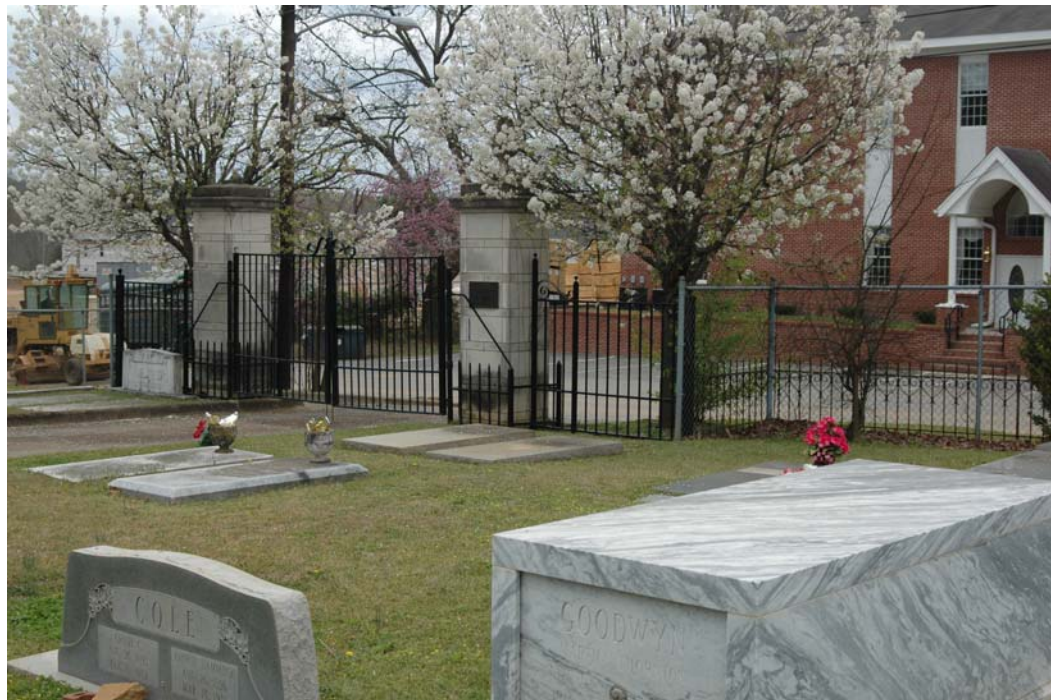
Figure 10. Discordant gate settings at Memory Hill. Both gates indiscriminately mix historic fabric and modern materials, detracting from the historic significance of the property (top is gate on W. Franklin, bottom is the gate on S. Clark).

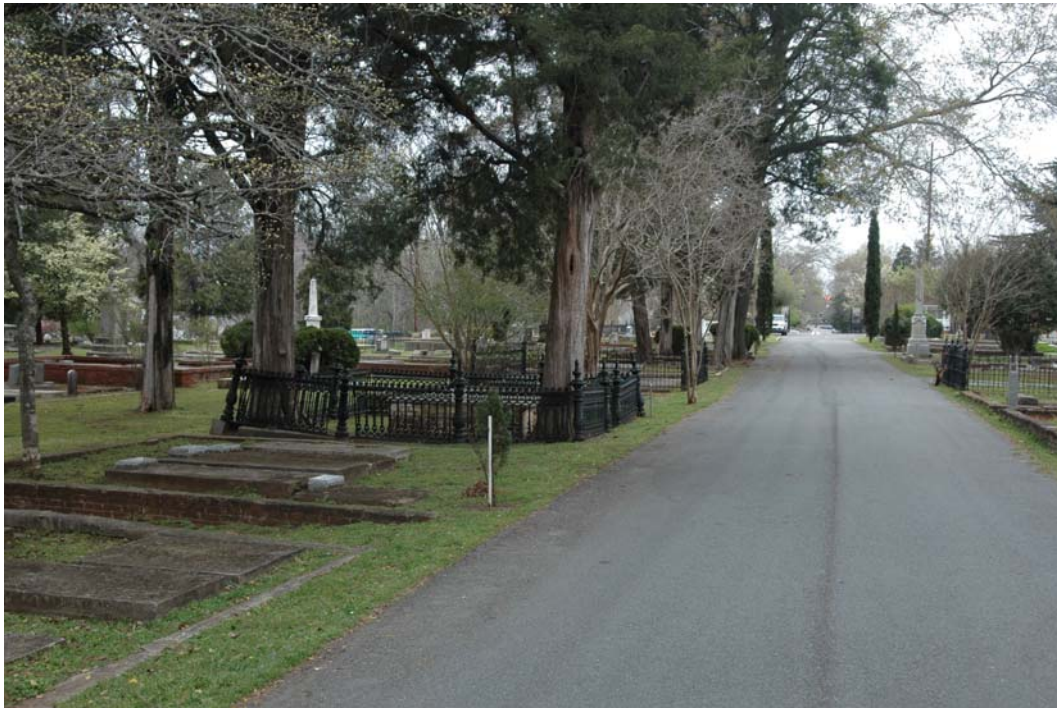
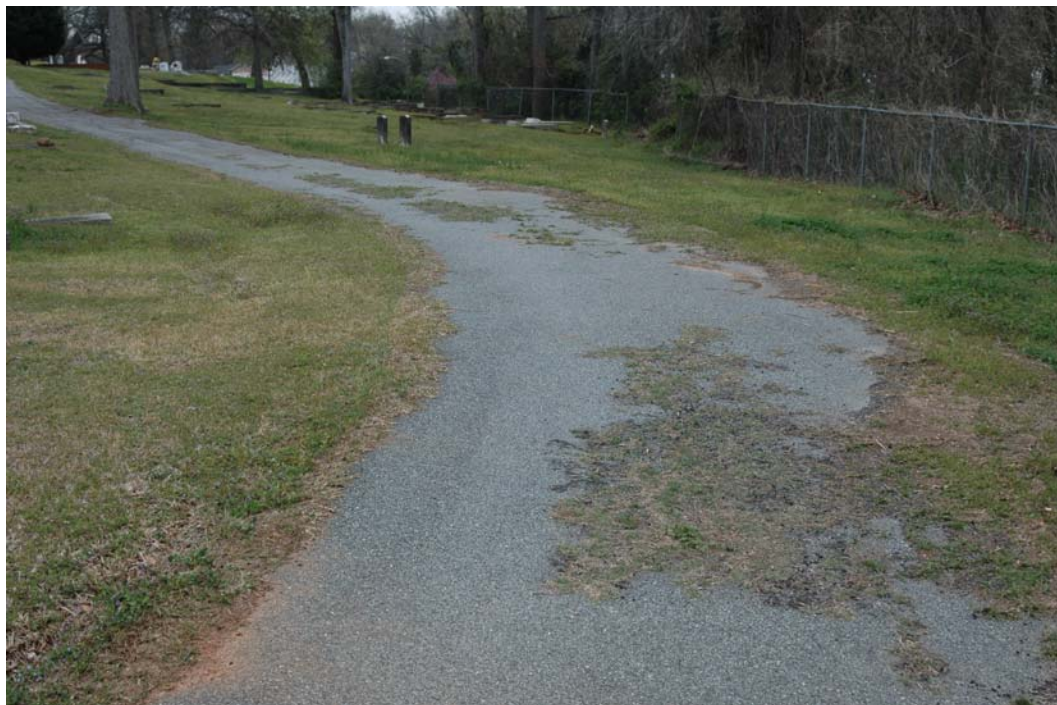
Figure 11. Roads in Memory Hill Cemetery. The top photograph shows the main entrance road. On the bottom is the horseshoe road in the African American section, showing deterioration and grass growing through the asphalt.

Another issue the City should address in the near-term is the rehabilitation of the roads in the African American section. The grass penetrating the road indicates little base material and a very thin asphalt wear layer – possible evidence of a low quality job.

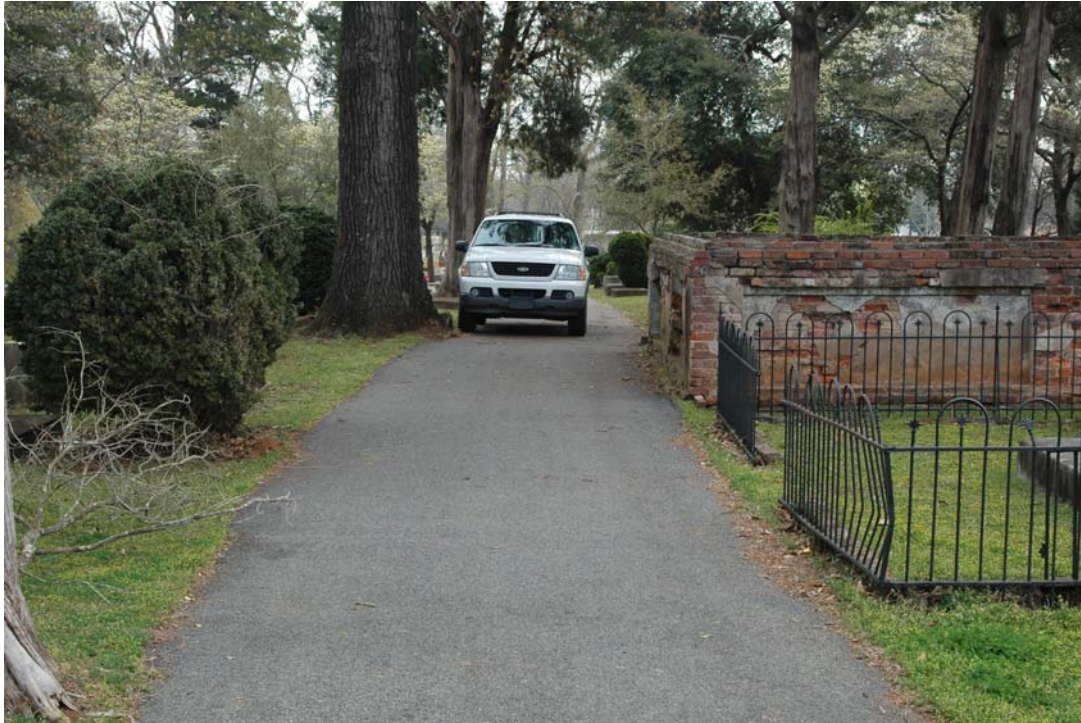
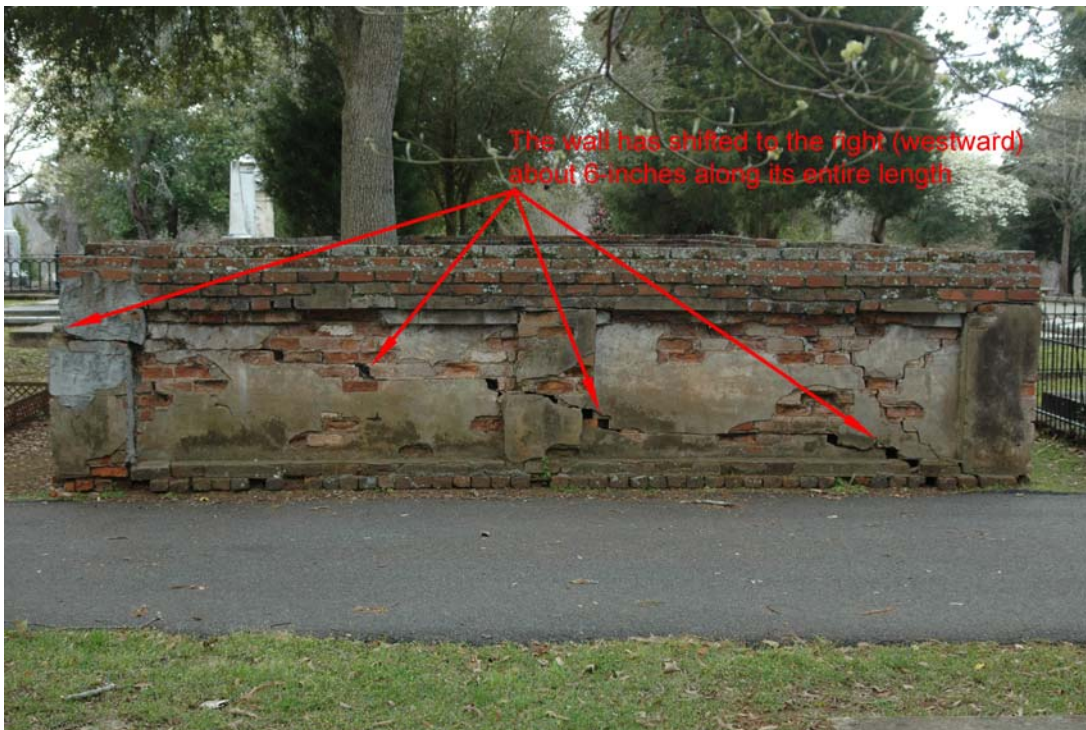
Figure 12. Example of narrow arterial road that should be closed – and the damage to a brick wall caused by vehicular traffic.

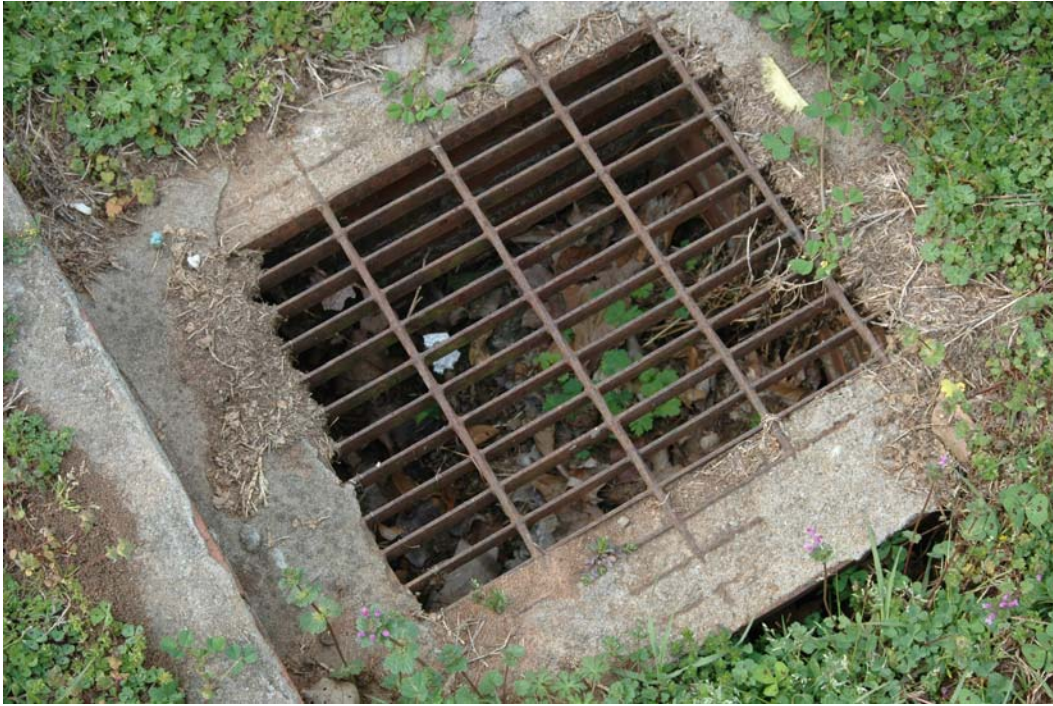
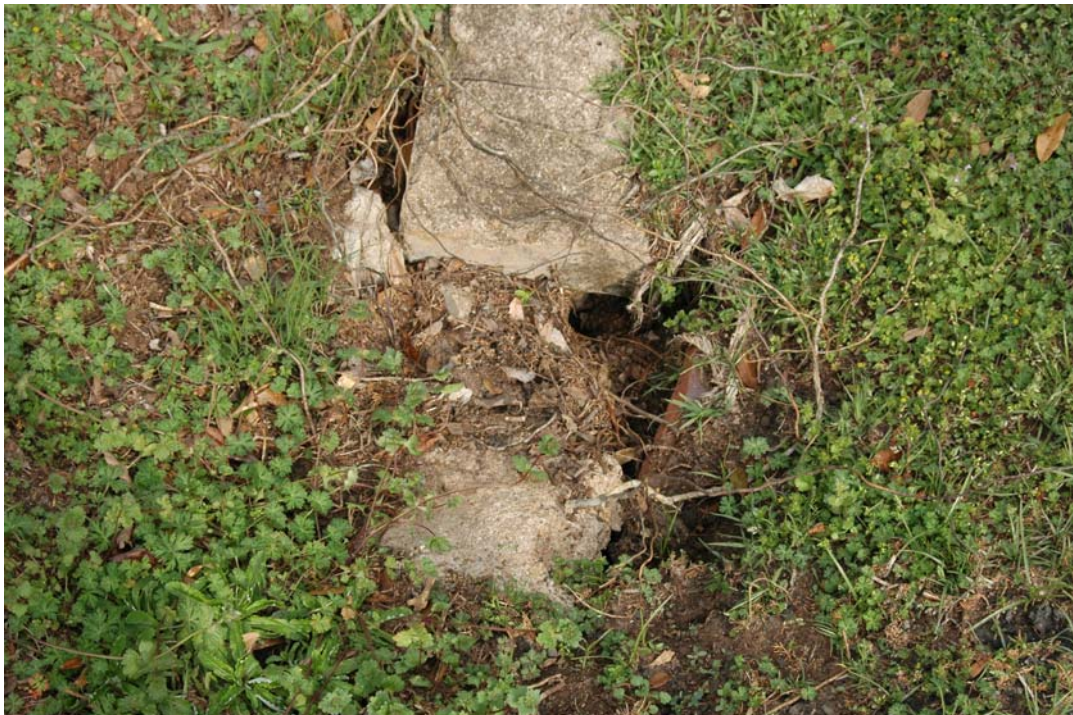
Figure 13. Critical drainage problems at Memory Hill include clogged catch basins (top) and collapsing drain lines (bottom). These require immediate attention from the City.

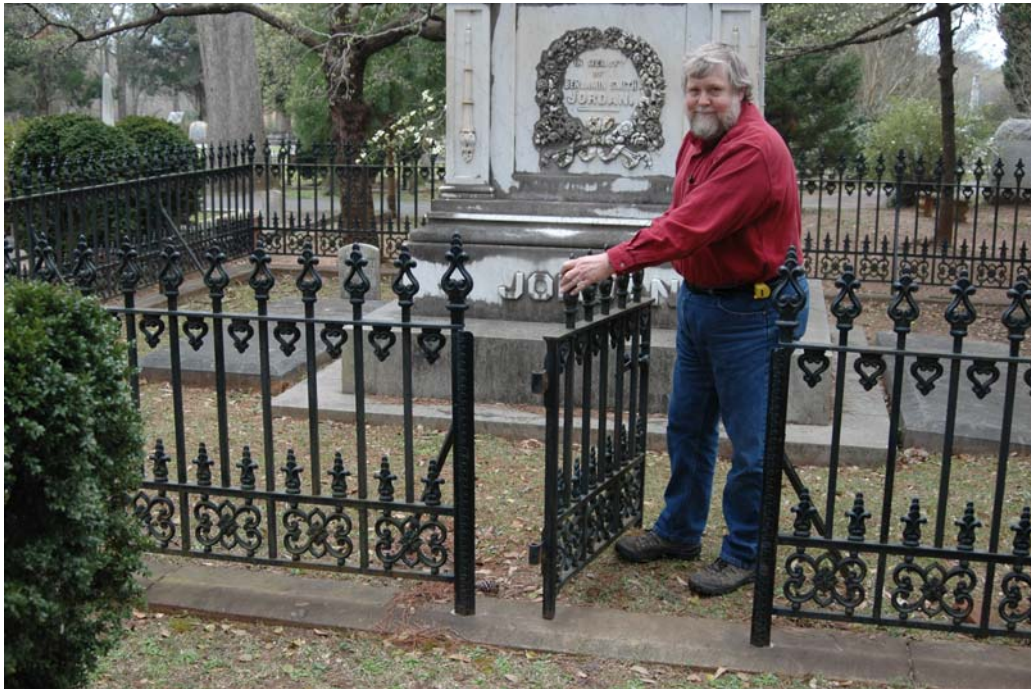
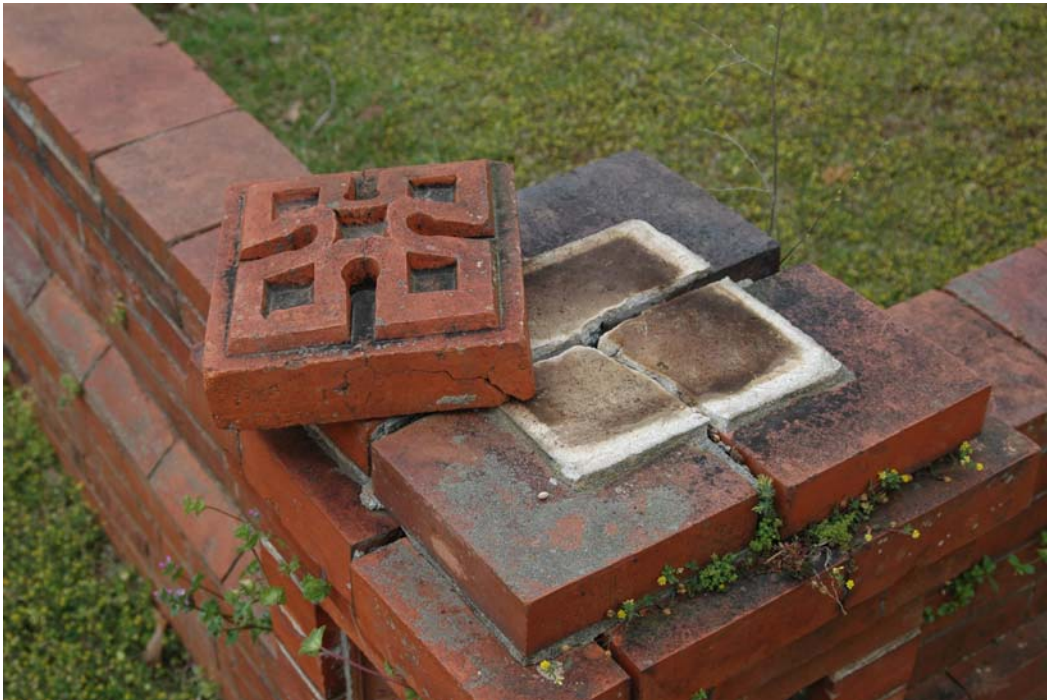
Figure 14. Immediate intervention is needed to prevent loss of historic fabric. The top photograph shows how easily gates could be removed from the cemetery. The lower photograph shows how decorative brick could be removed.

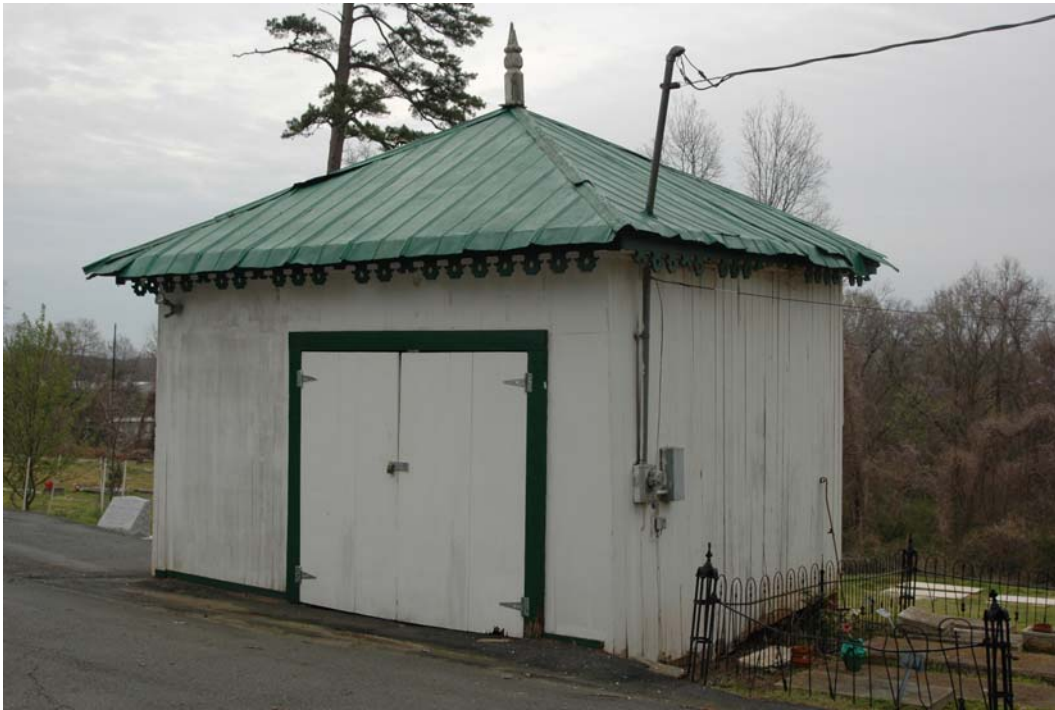
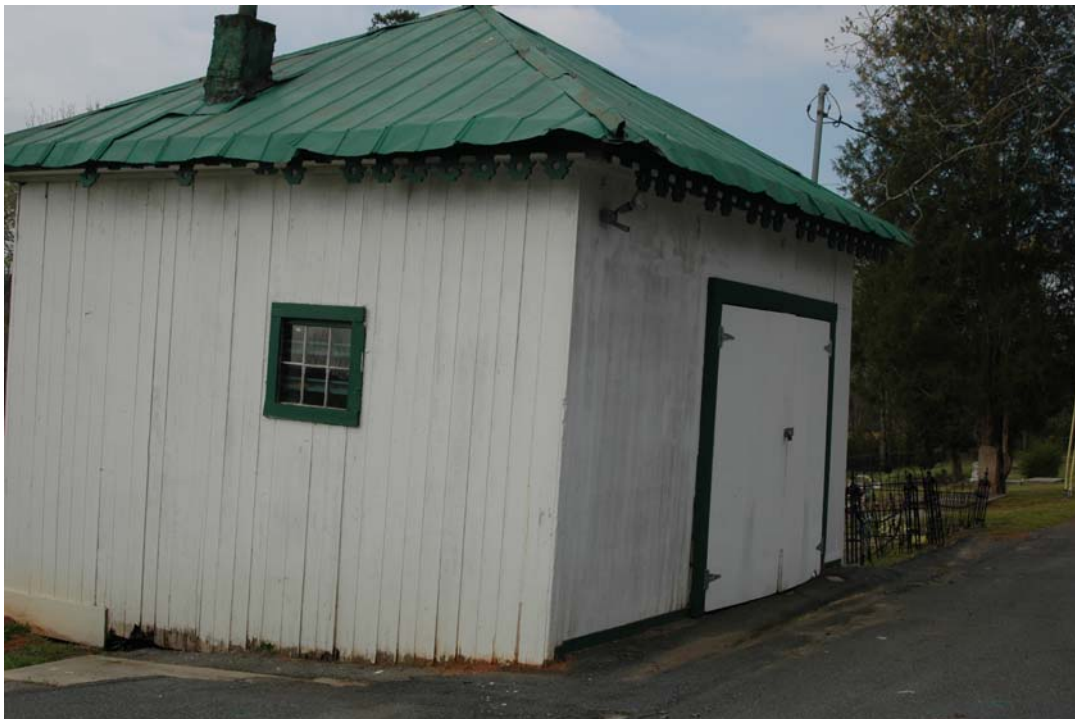
All broken stones that are picked up for storage prior to repair must be inventoried, with their exact location noted. There must be some practice whereby this information is attached to the stone fragments – ensuring that they can be repaired and returned to the cemetery. All of the debris behind the building – and visible to those visiting the African American cemetery section – should be picked up and appropriately stored.

Figure 15. Sexton's shed at the rear of the cemetery. Top view is oblique looking to the southeast, bottom view is looking to the southwest.

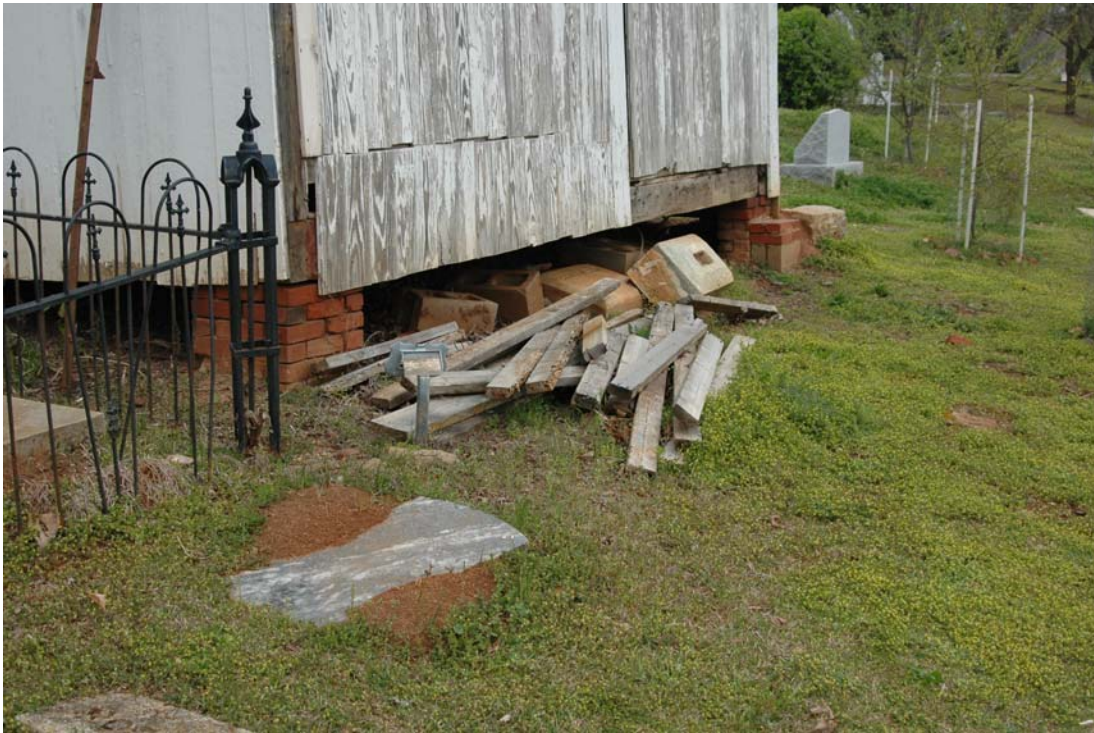
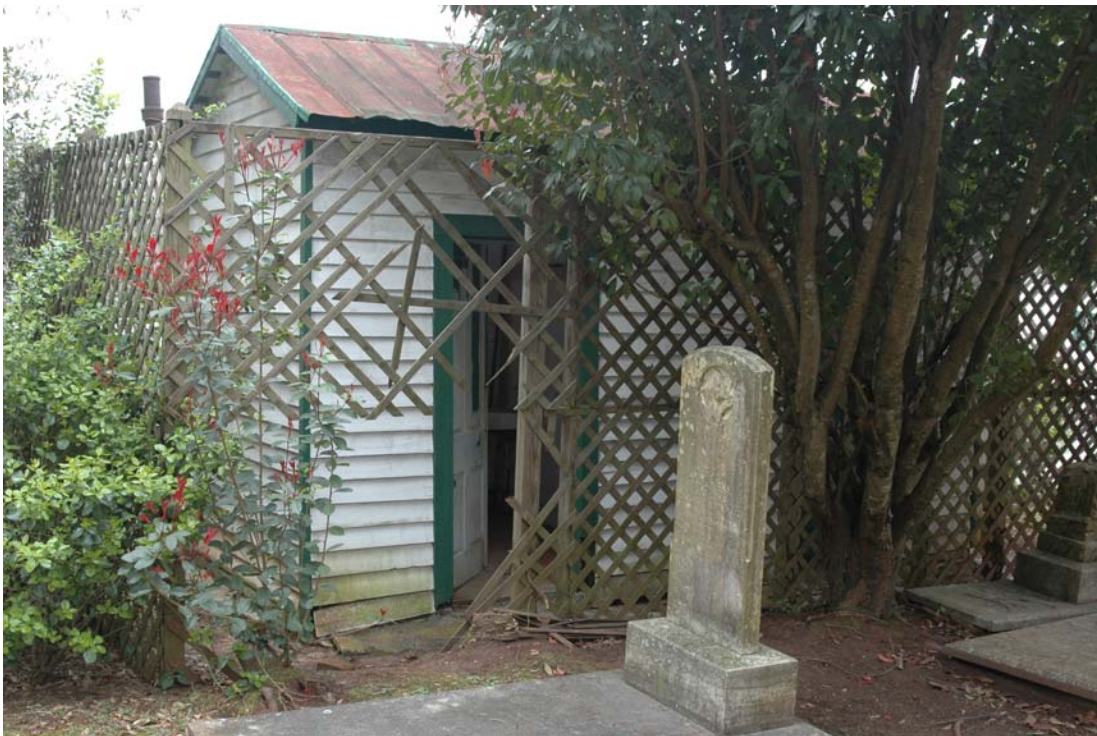
Figure 16. Debris behind the sexton's shed (top) and dilapidated condition of the bathrooms (bottom).

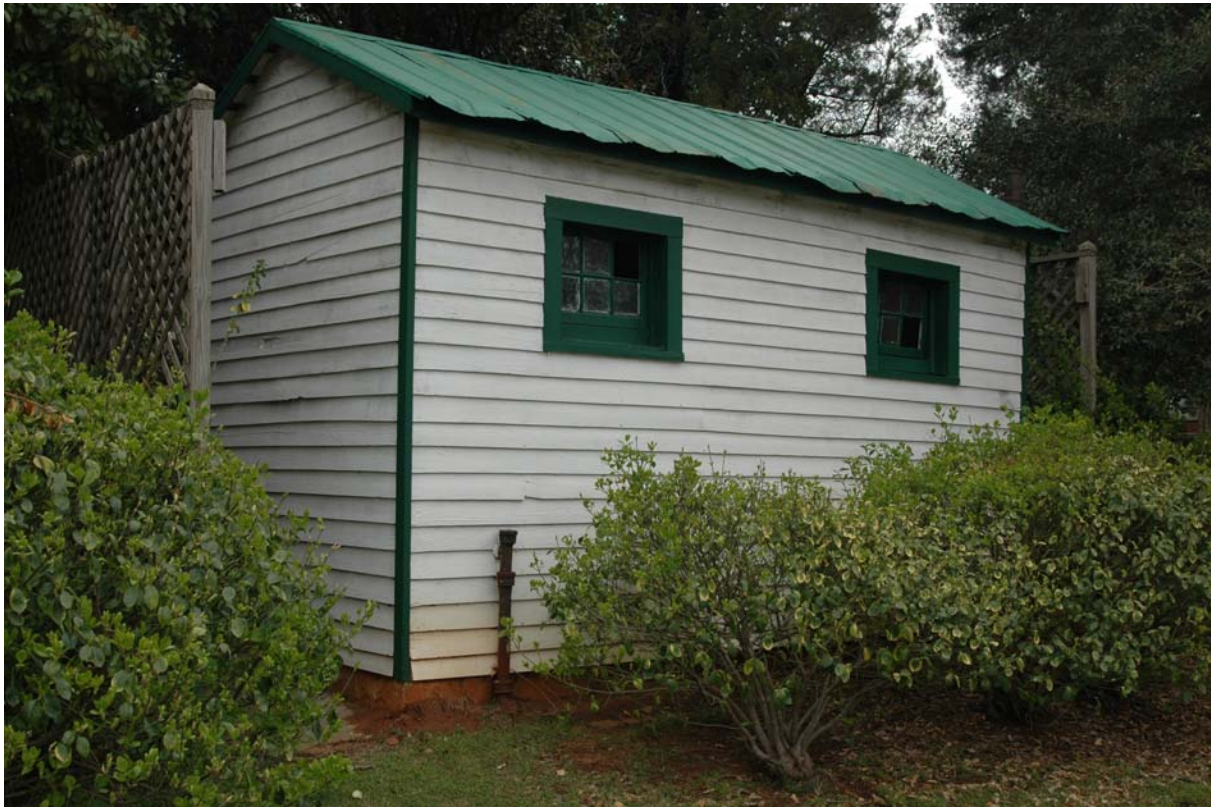
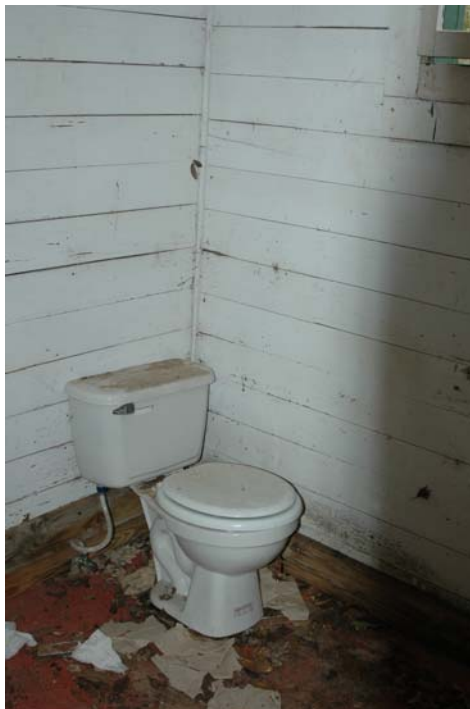
The other structure, immediately to the northeast of the sexton's shed is a bathroom. This structure has a metal gable roof and is of weatherboard construction set on a concrete slab. At the rear there are two 6/6 inwardly projecting windows. At the front are two entrances. The building itself is divided into two small bathrooms, each with a toilet and sink. The front is screened with a dilapidated lattice, as well as overgrown shrubs.

Figure 17. Bathroom condition at the cemetery.

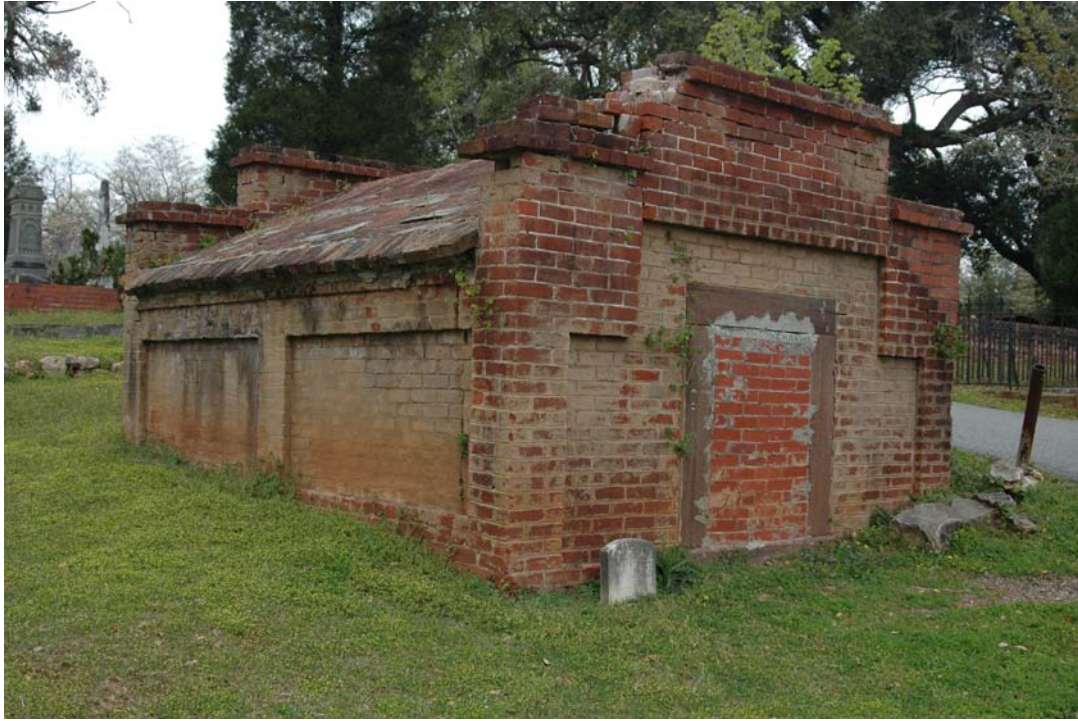
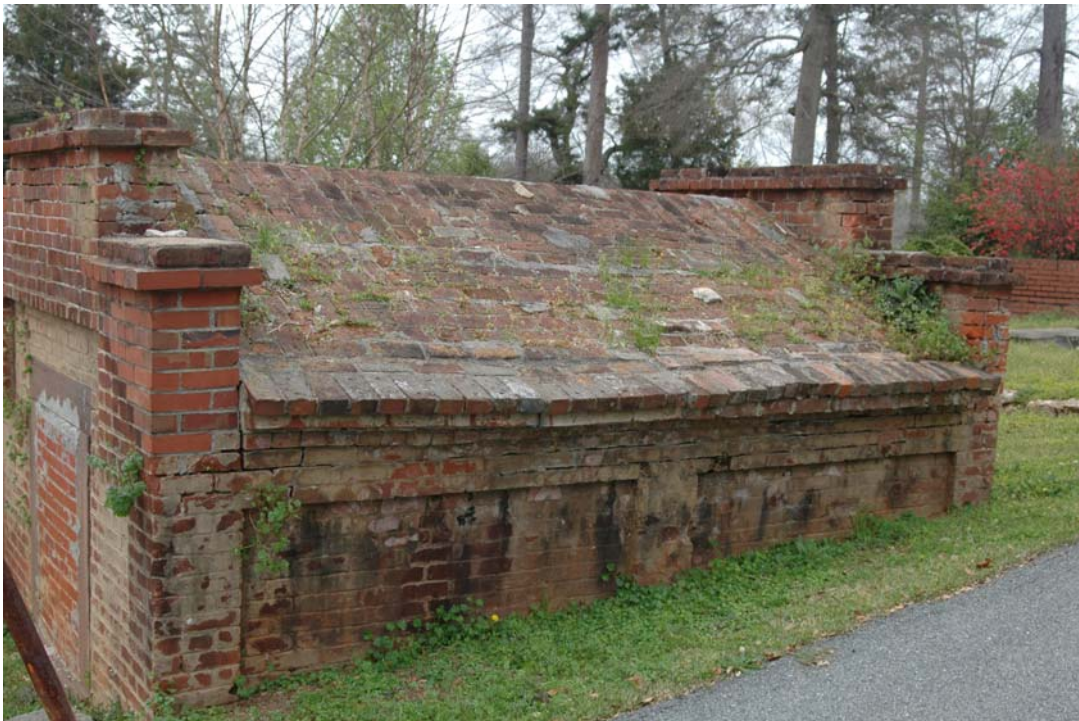
Figure 19. Brick vault at Memory Hill. Of particular concern is the damage to the right pediment, the abundant previous repairs using inappropriate materials, the need for repointing, and the abundant growth that is damaging the mortar joints.

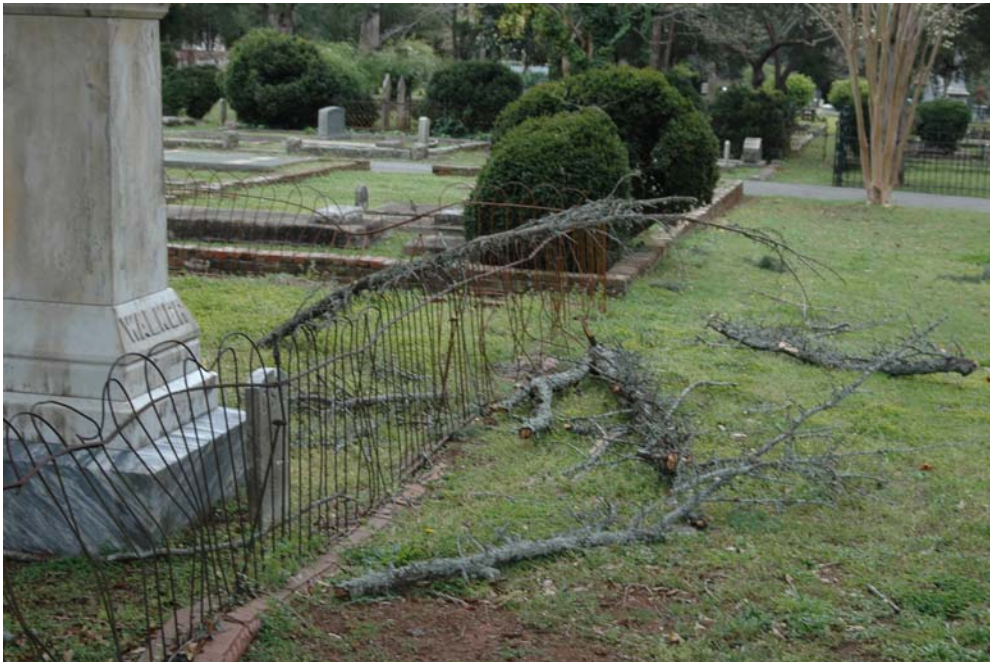
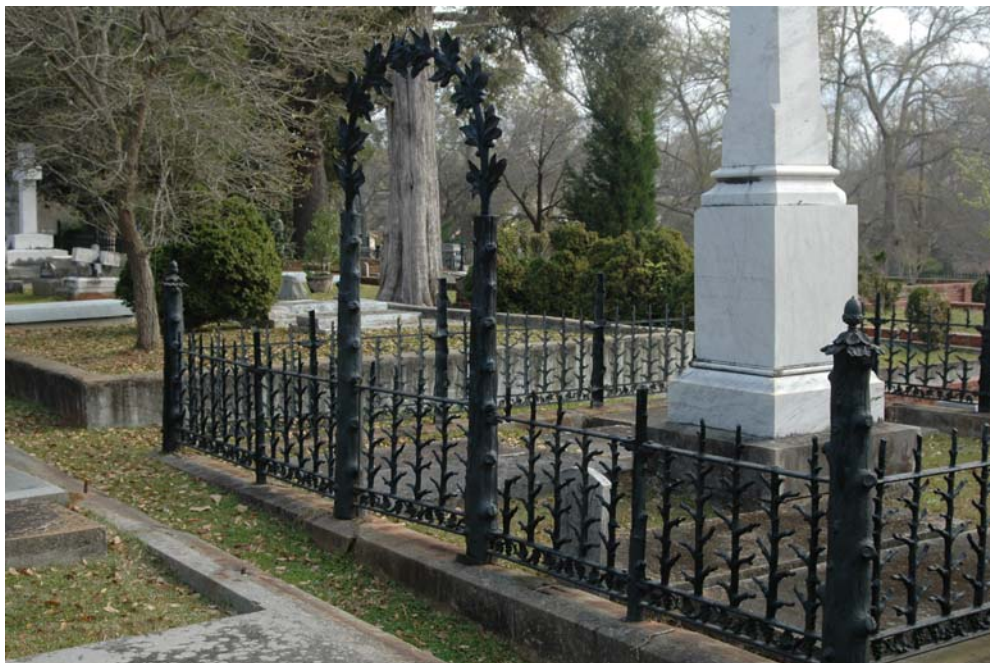
Figure 20. Variation in fence conditions. The top photograph shows a fence in very poor condition, resulting from a lack of maintenance coupled with damage resulting from poor landscape practices. The lower photograph shows a fence in overall good condition, representing a very elaborate stalk design.

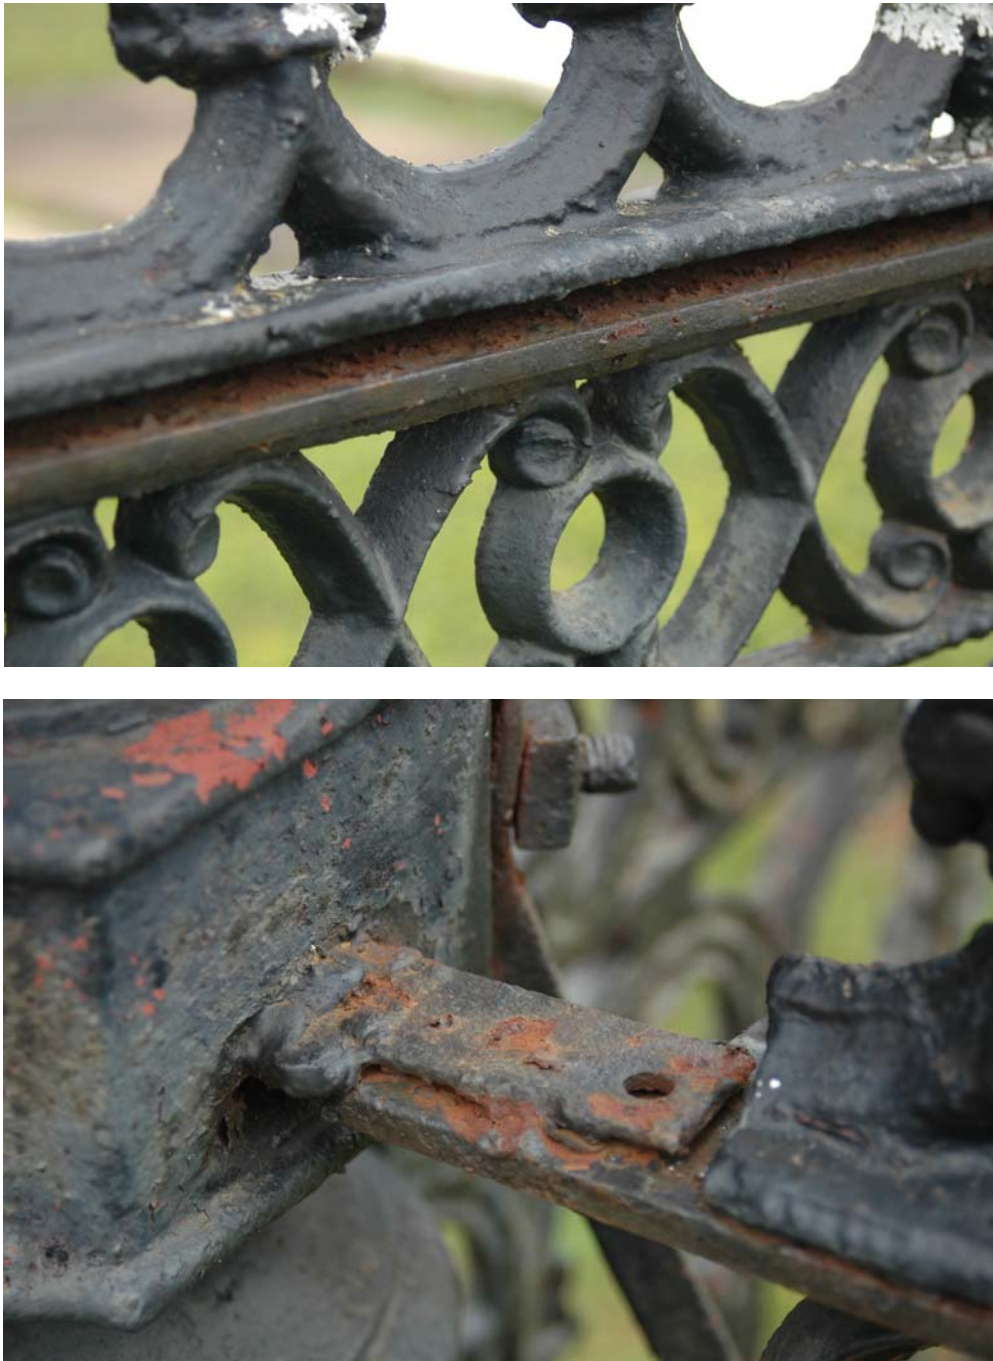
Figure 21. Fence problems. The top photograph shows corrosion occurring between railing components where moisture is drawn through capillary action and where caulk is critical. The lower photograph shows an inappropriate weld that prevents movement in the fence parts and damages the aesthetics of the fence. The weld also retains moisture, accelerating corrosion in this area.

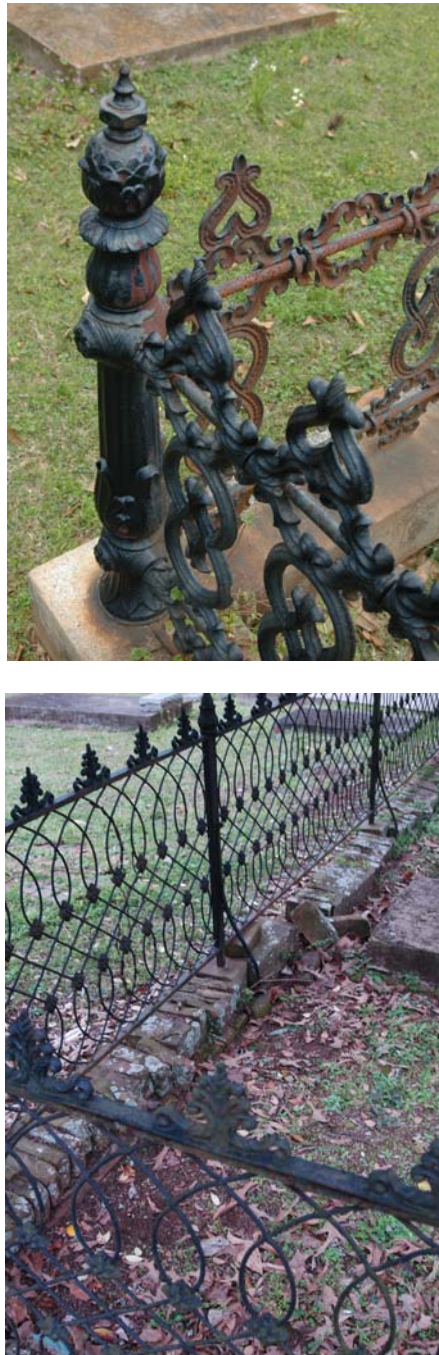
Figure 22. Other fence problems. The top photograph shows a fence that has had only the exterior painted, allowing the interior of the ironwork to corrode. The lower photograph shows damage to the brick wall on which the fence is set. Appropriate maintenance requires that these walls be maintained using appropriate mortars that match the original in color, texture, tooling, and softness.

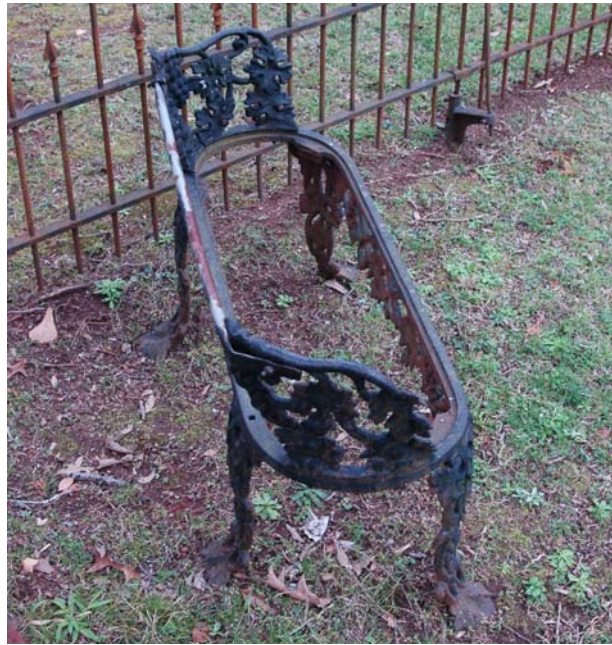
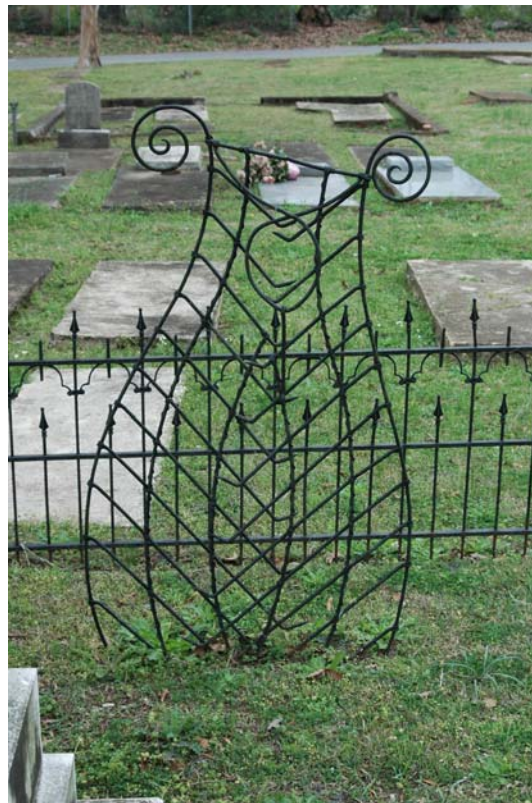
Figure 23. Examples of other amenities. The top photograph shows a no longer functional iron bench that should be either repaired or removed from the plot. The lower photograph shows a trellis that requires the same attention as other cemetery ironwork.

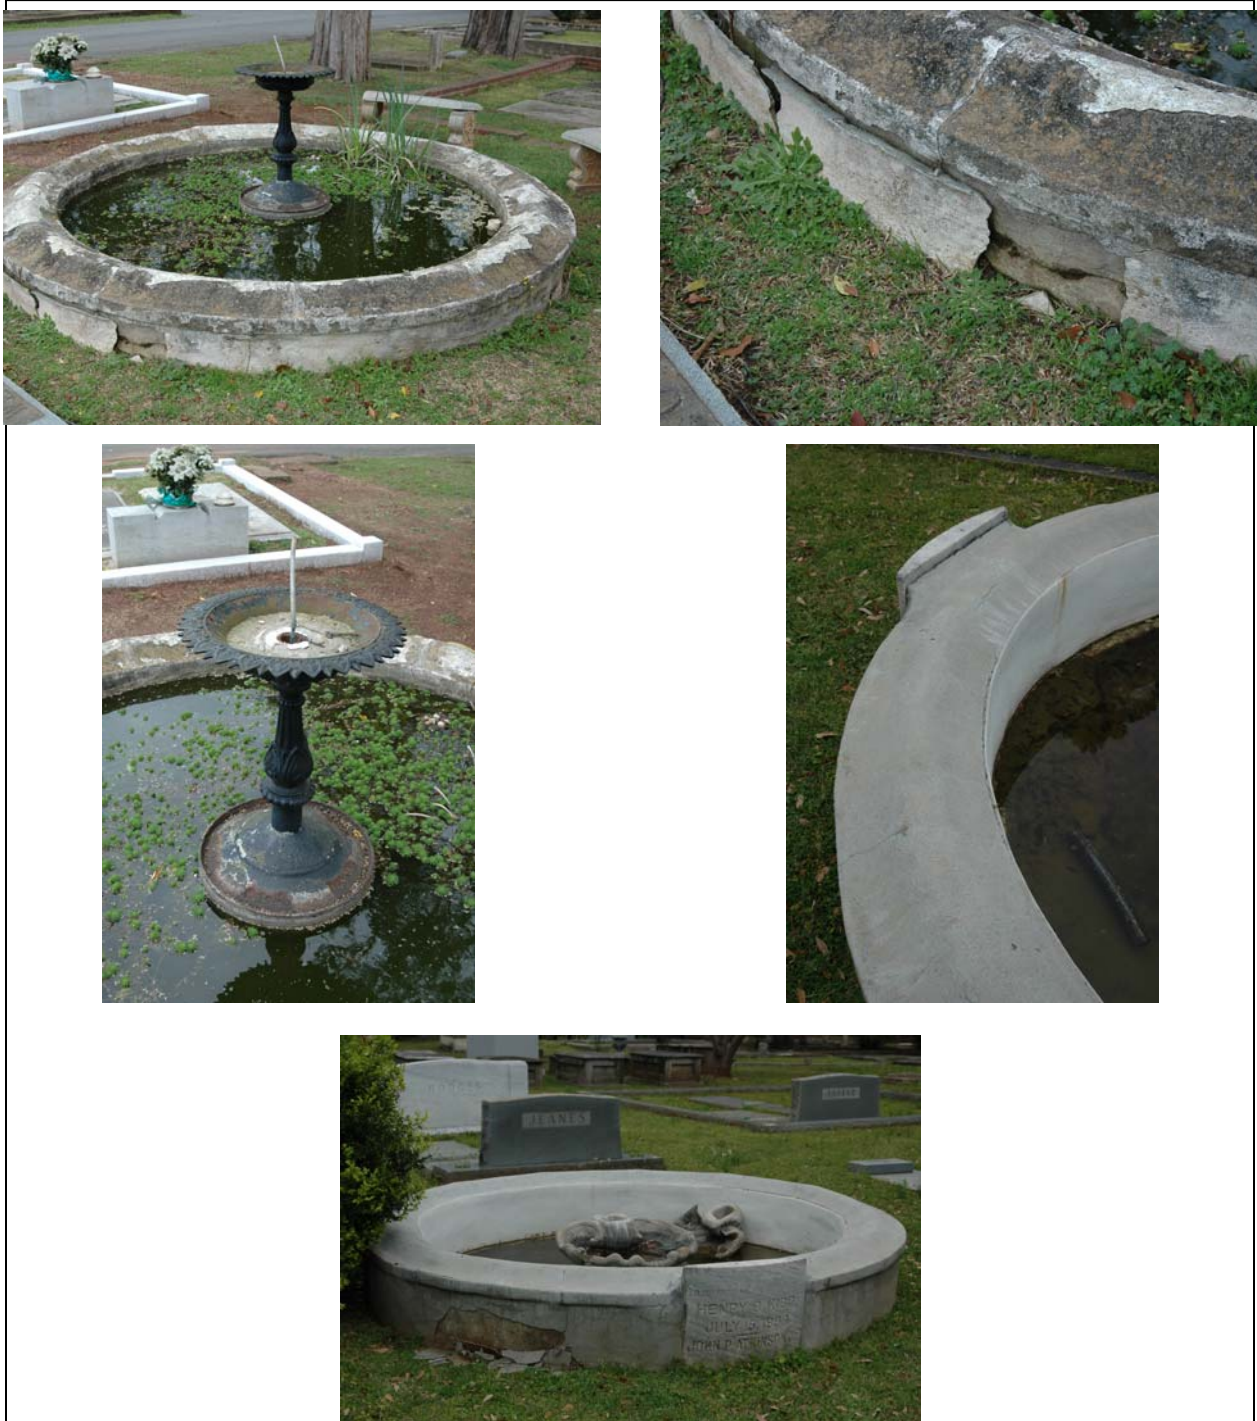
Figure 24. Fish ponds at Memory Hill. The upper two photographs illustrate the pond at the entrance to the cemetery; note the spalling stucco. The middle left photograph shows the corrosion to the inoperable foundation. The middle right photograph shows the new stucco on the rear fish pond is already beginning to fail. The lower photograph shows the rear pond, with stucco cracked and collapsing from the side walls.
